# 2023 Annual Inspection of the Northwest Parkway

October 6, 2023

Northwest Parkway, LLC  
3701 Northwest Parkway  
Broomfield, CO 80023  
Contact: Mr. Pedro Costa

Stantec Consulting Services Inc.  
410 17th Street  
Suite 1400  
Denver, Colorado 80202  
Contact: Ryan Nataluk, PE

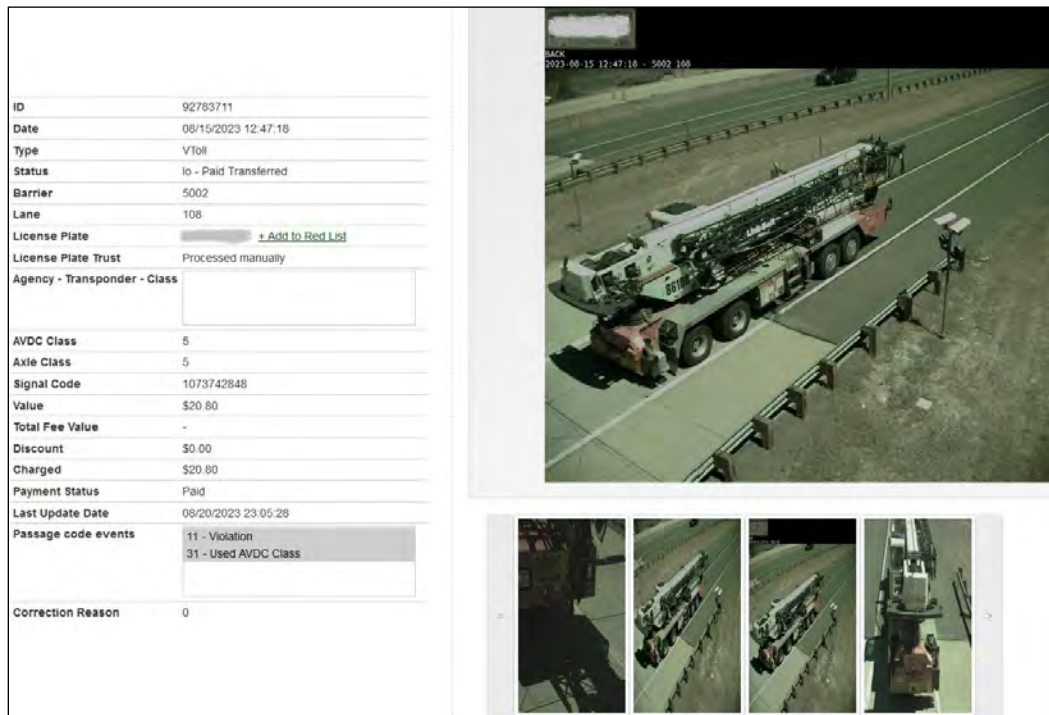
Figure 3: Misclassification of 4-Axle Vehicle

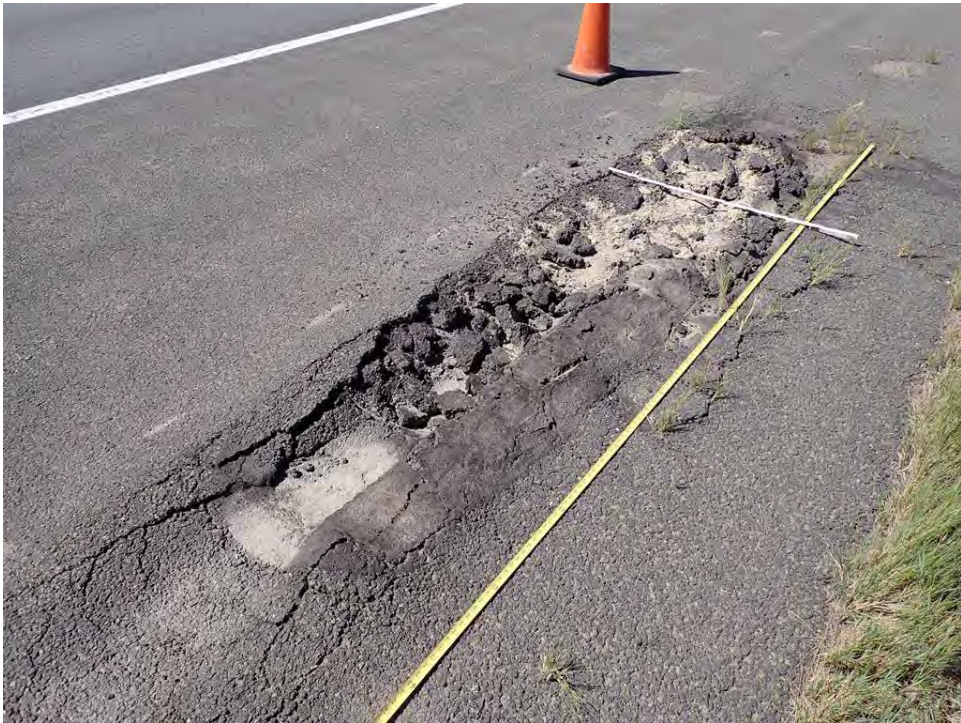
- **Ruts more than 1 ½ inches:** There were a few areas of rutting more than 1 ½ inches in depth observed during the inspection. Areas of rutting more than 1 ½ inches in depth was observed at the following locations:
  - North shoulder along westbound at milepost 49.1 – Rut up to 1 ¾ inches in depth
  - North shoulder along westbound at milepost 52.6 – Rut 13 feet in length x 4 feet in width x up to 6 inches in depth with up to 5 inches of asphalt heaving adjacent to rut – **Category 1 Defect**
  - North shoulder along westbound off-ramp at US 287 – Rut up to 2 inches in depth

Photo 4: Asphalt Heaved up to 5 Inches at Rutting in North Shoulder, Westbound at Milepost 52.6

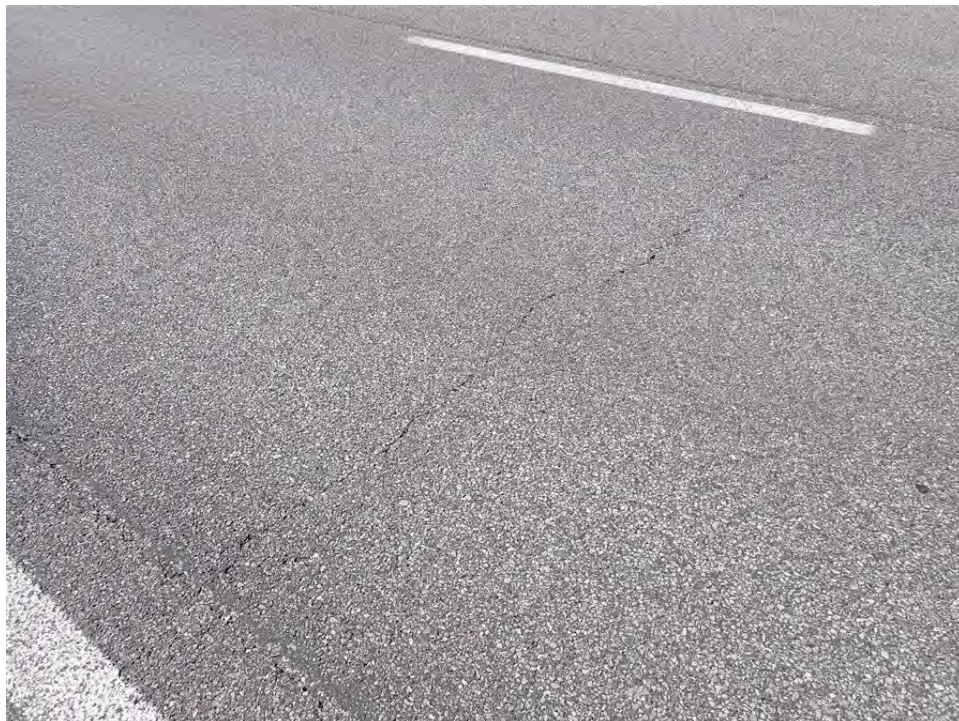
- **High severity area cracking:** There was no high severity area cracking observed during the inspection. **Score: 5.0**
- **Transverse cracks:** Transverse cracks were observed during the inspection. There were several previously sealed transverse cracks that were observed to be re-cracking. See Photo 8 for typical transverse cracks observed during the inspection and Photo 9 and Photo 10 for previously sealed cracks that are re-cracking. Annual crack sealing is scheduled for October of this year. **Score: 4.50**

Photo 9: Poorly Sealed Transverse Crack in Asphalt, Westbound at Milepost 47.1

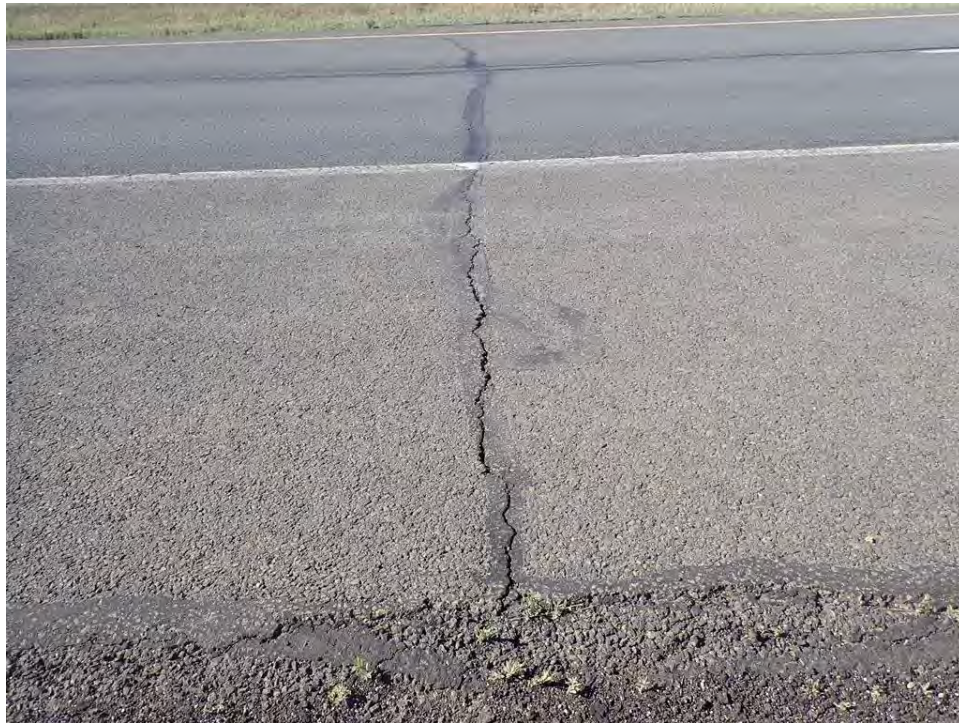
Photo 10: Previously Sealed Transverse Crack in Asphalt Re-cracking, Westbound at Milepost 53.3

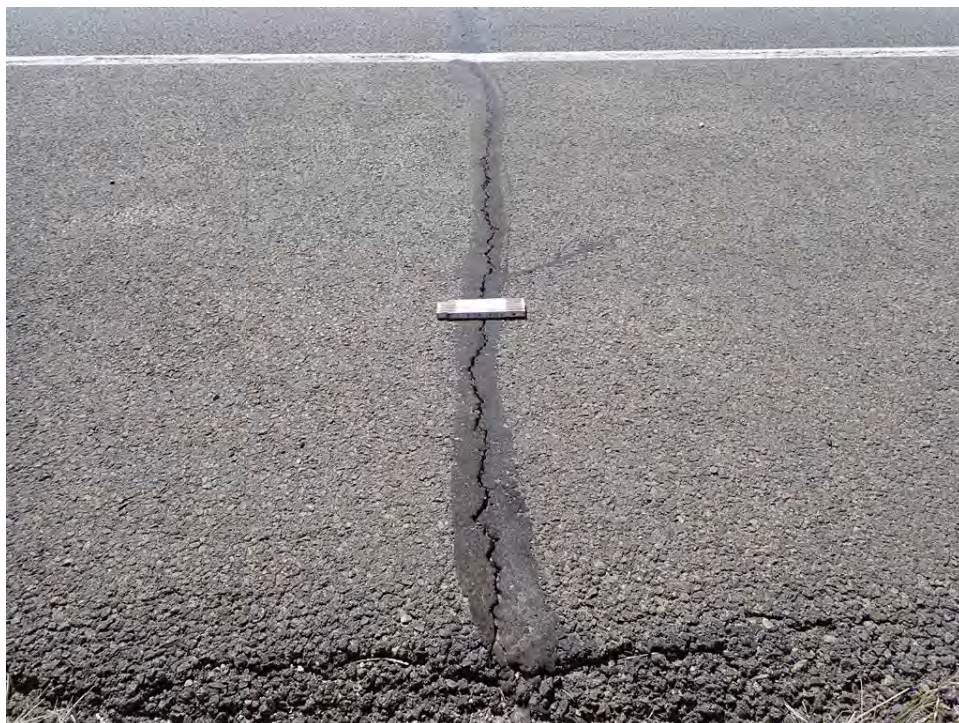
- **Longitudinal cracks:** Longitudinal cracks were observed during the inspection. See Photo 11 and Photo 12 for typical longitudinal cracks observed during the inspection. Annual crack sealing is scheduled for October of this year. **Score: 4.80**

Photo 11: Longitudinal Crack in Asphalt, Westbound at Milepost 53.3

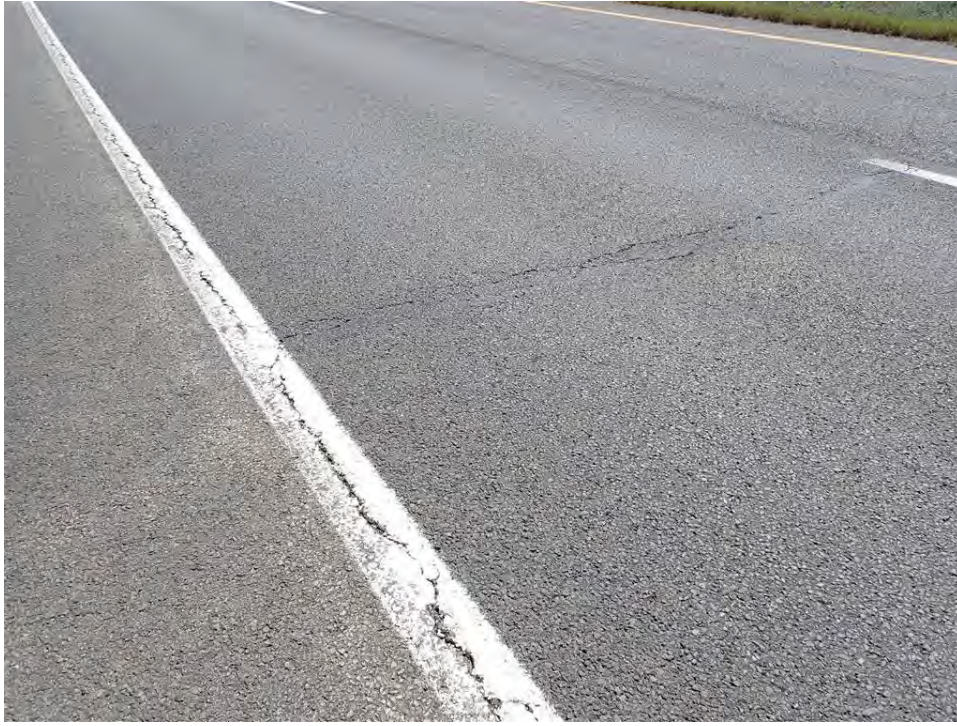
Photo 12: Poorly Sealed Longitudinal Crack in Asphalt, Westbound at Milepost 48.7

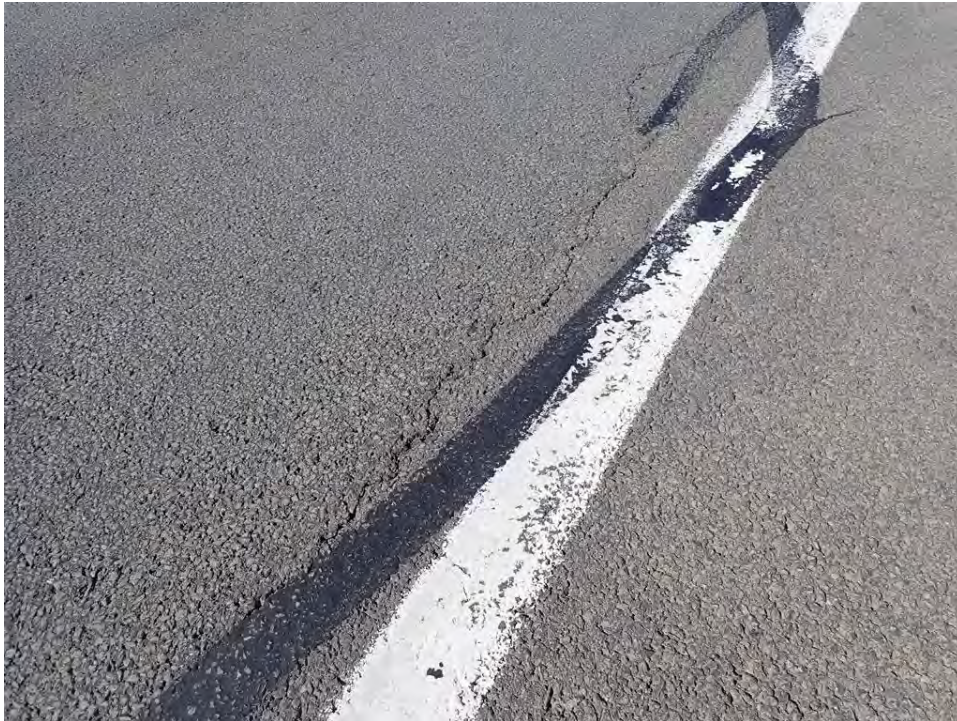
- **Potholes:** There were a few areas of potholes observed during the inspection. Potholes were observed at the following locations:
  - White line along westbound at milepost 48.15 – two (2) potholes up to 2 feet in length x 6 inches in width x 2 ½ inches in depth

Photo 13: Pothole in Asphalt, Westbound at Milepost 48.15

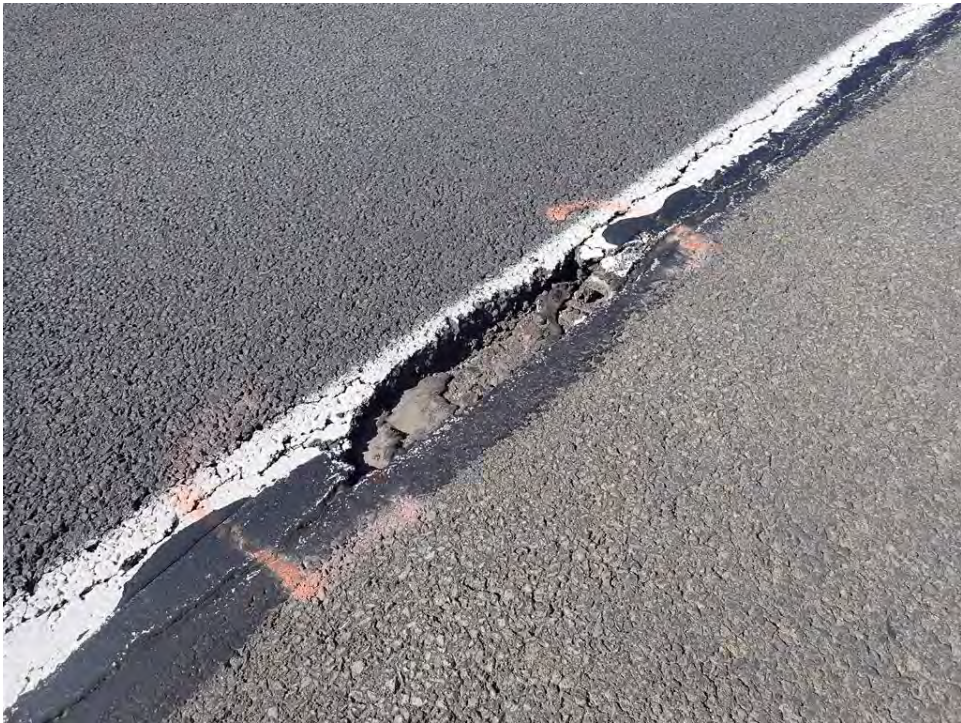
Photo 14: Patched Pothole in Asphalt, Westbound at Milepost 48.15

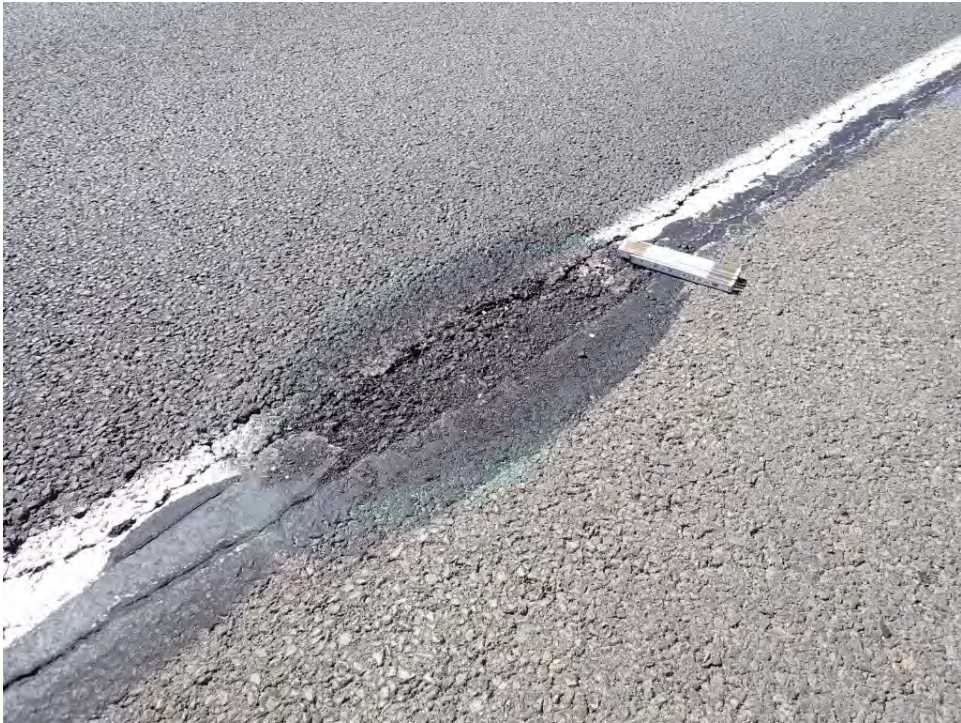
Photo 15: Potholes in Asphalt, Eastbound at 96<sup>th</sup> Steet

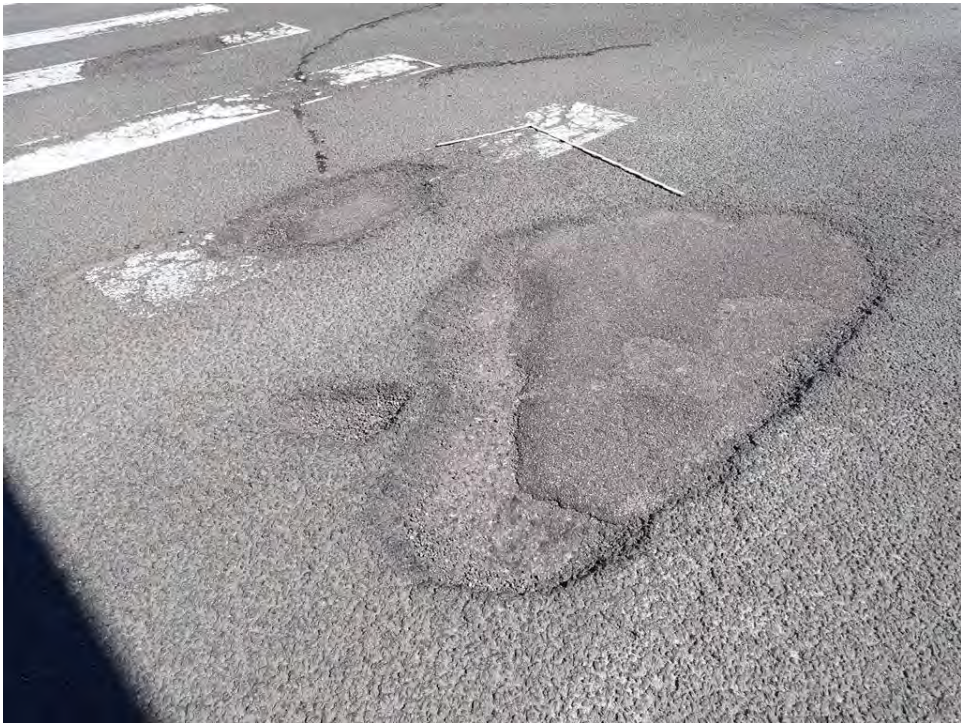
Photo 16: Repaired Potholes in Asphalt, Eastbound at 96<sup>th</sup> Steet

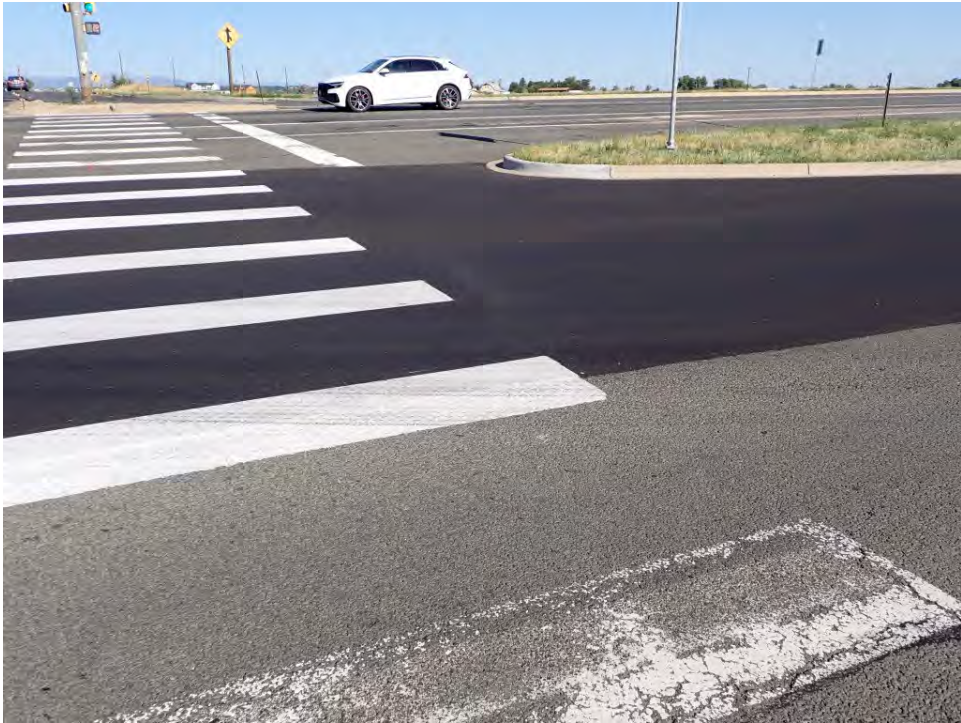
Photo 17: Scrapes and Pothole in Asphalt, Eastbound at Off-Ramp to I-25

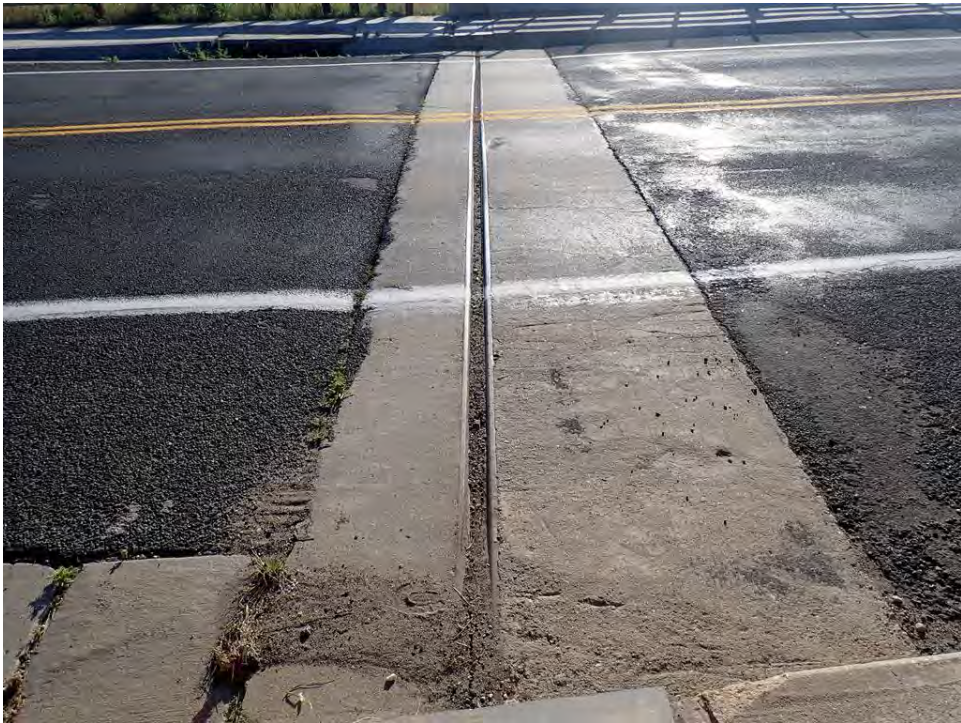
- **Mechanical bridge joints in rigid pavement:** The mechanical joints at the overpass structures at Huron Street, Lowell Boulevard, 120<sup>th</sup> Street, and 104<sup>th</sup> Street were observed to be full of debris. The joints at the bridges on Northwest Parkway at the US 287 interchange were observed to have minor, loose debris in the travel lanes and moderate debris in the shoulders. See Photo 18 through Photo 22, and Photo 24. Prior to the reinspection, the joints at the bridges at the US 287 interchange were cleaned. However, during the reinspection, minor debris was observed in the joints in the shoulders from the recent sweeping operations, as shown in Photo 23 and Photo 25. **Score: 4.60**

Photo 20: Dirt in Expansion Joint at 120<sup>th</sup> Overpass

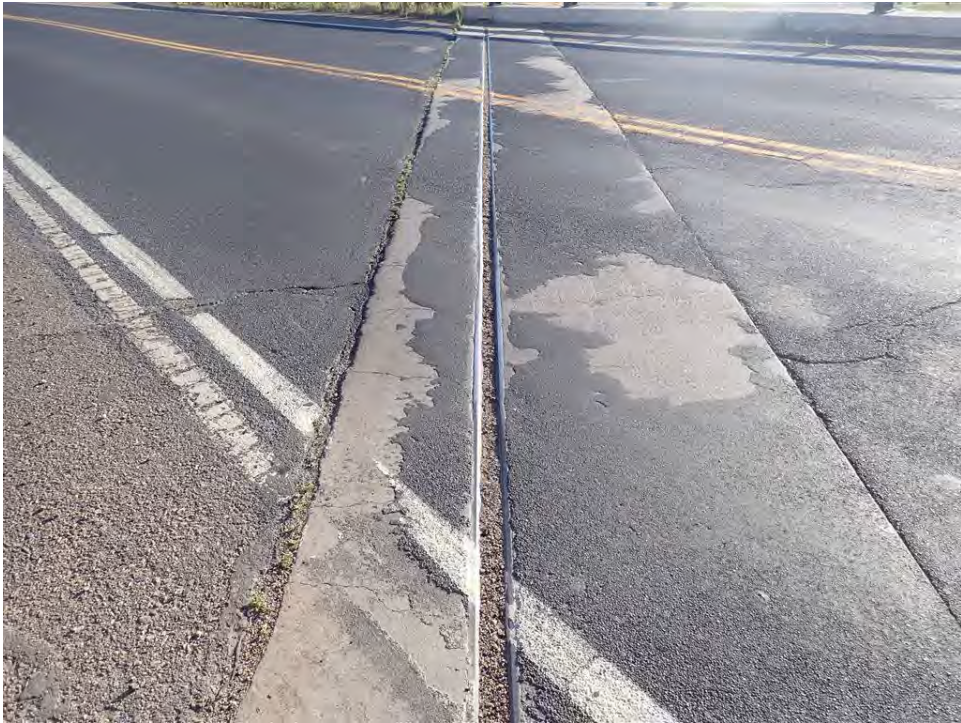
Photo 21: Dirt in Expansion Joint at 104<sup>th</sup> Overpass

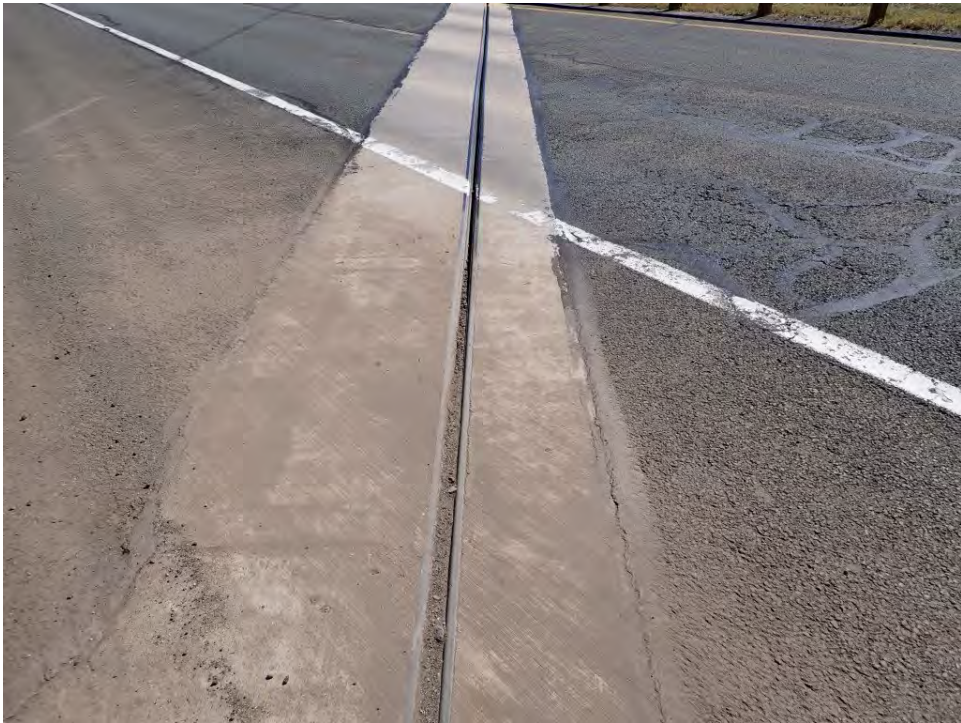
Photo 24: Dirt in Expansion Joint at Bridge over US 287, Eastbound

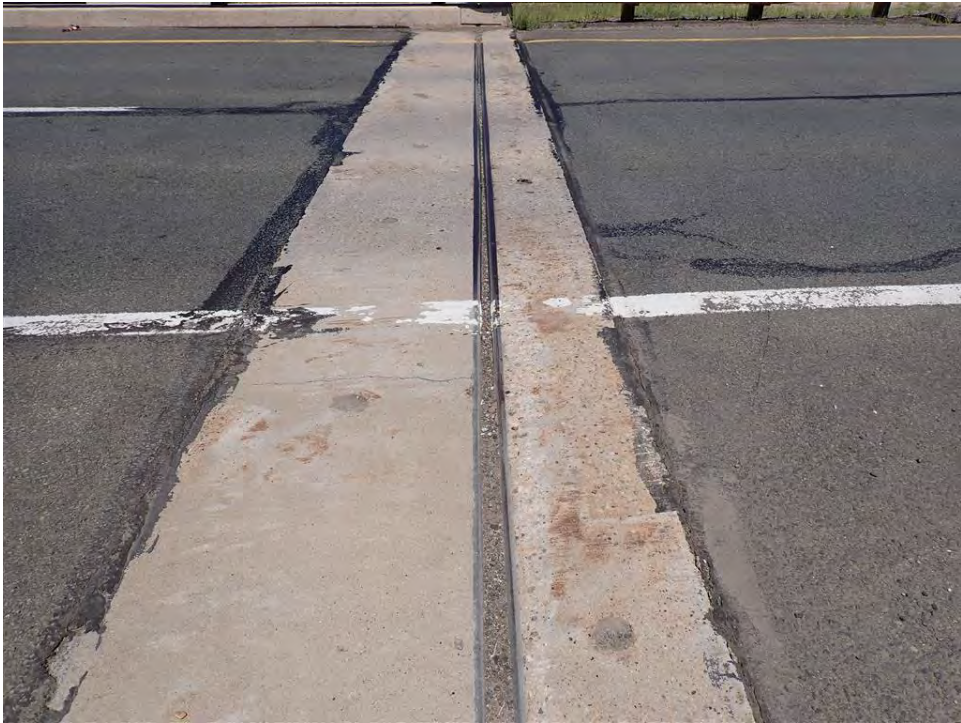
Photo 25: Cleaned Expansion Joint at Bridge over US 287, Eastbound

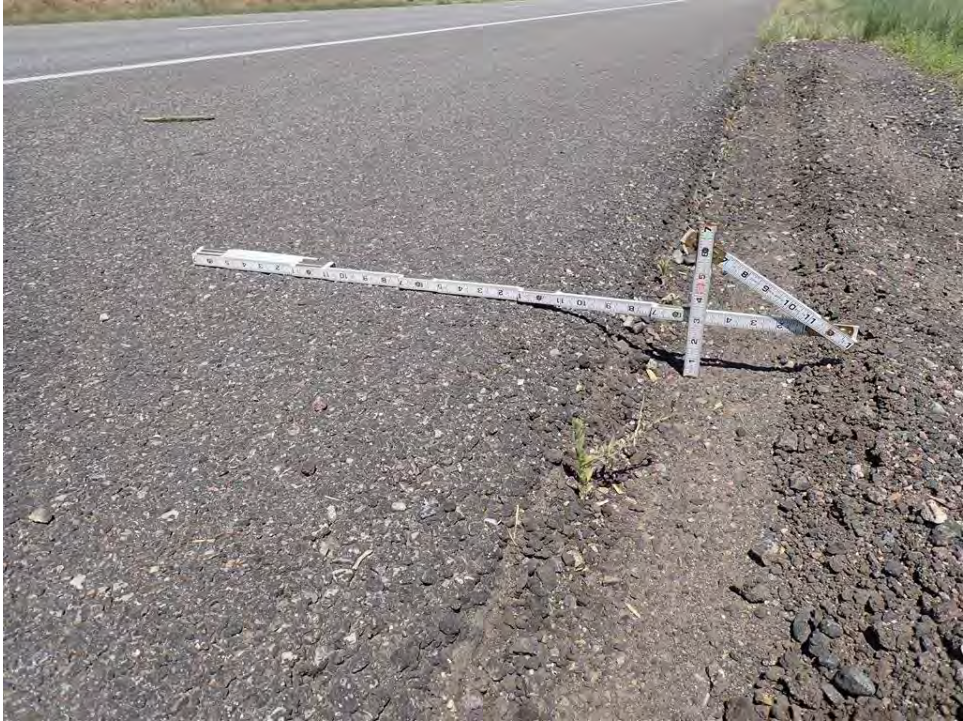
See Photo 27 through Photo 30. At the time of reinspection, some of the shoulder drop-offs had been repaired. **Score: 4.55**

Photo 27: Shoulder Drop-Off, Westbound at Milepost 47.1

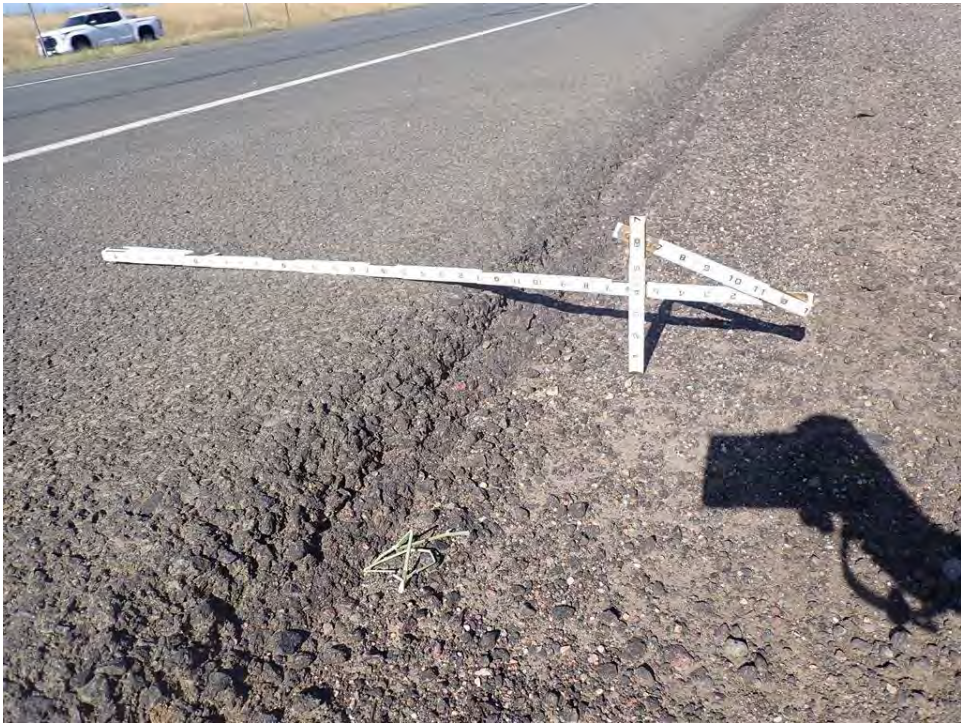
Photo 28: Shoulder Drop-Off, Eastbound at Milepost 46.75

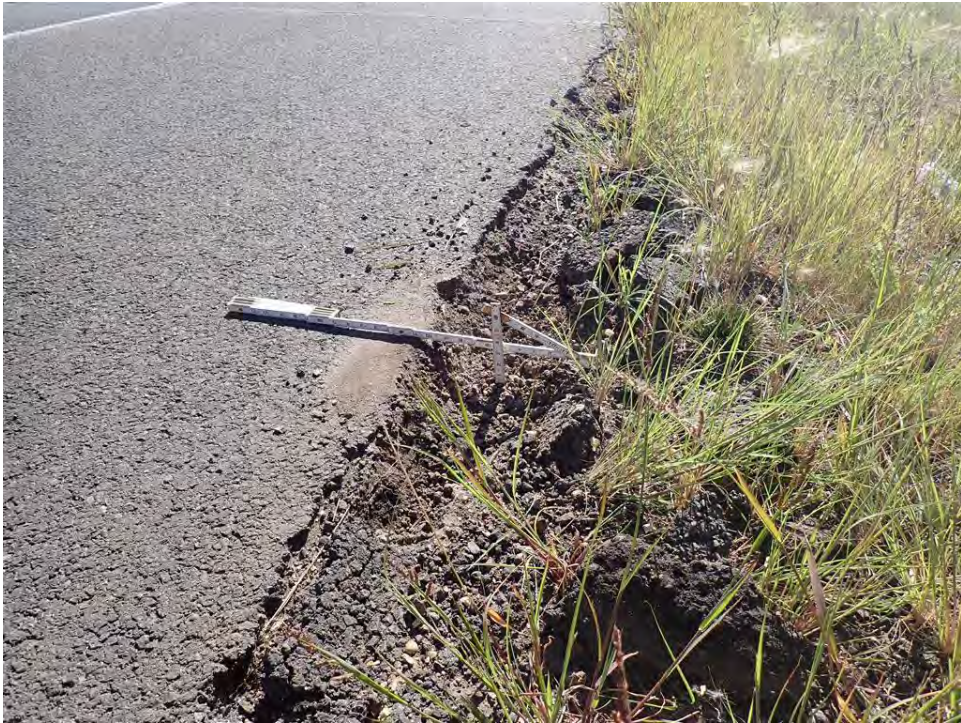
Photo 29: Shoulder Drop-Off, Eastbound at Milepost 46.95

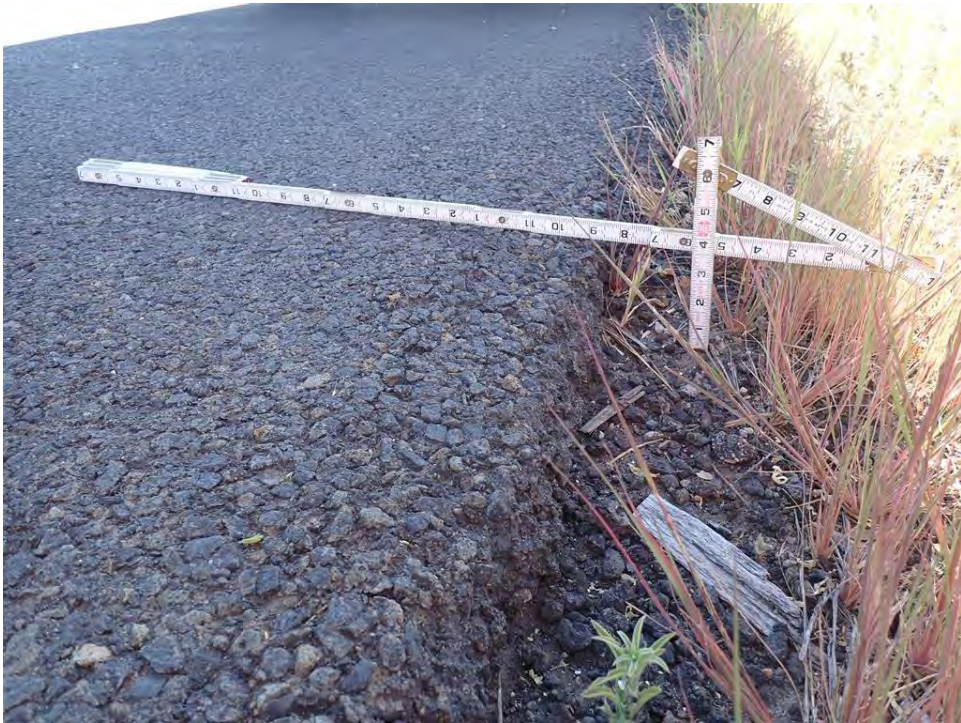
Photo 30: Shoulder Drop-Off, Eastbound at Milepost 48.75

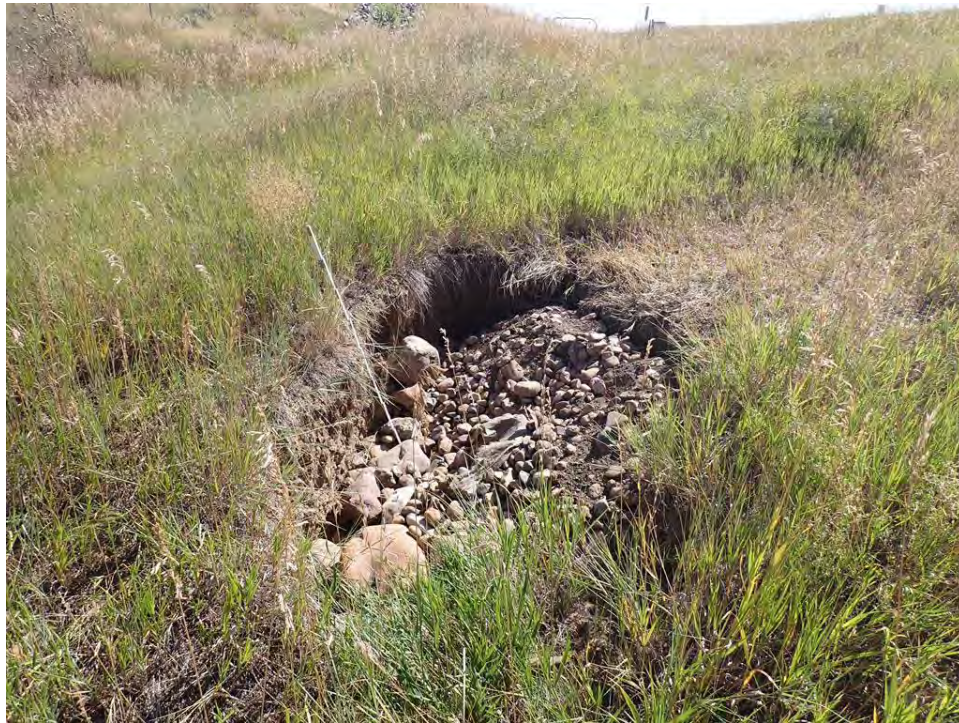
Photo 34: Erosion Trough and Displaced Riprap in North Slope, Westbound at Milepost 51.05

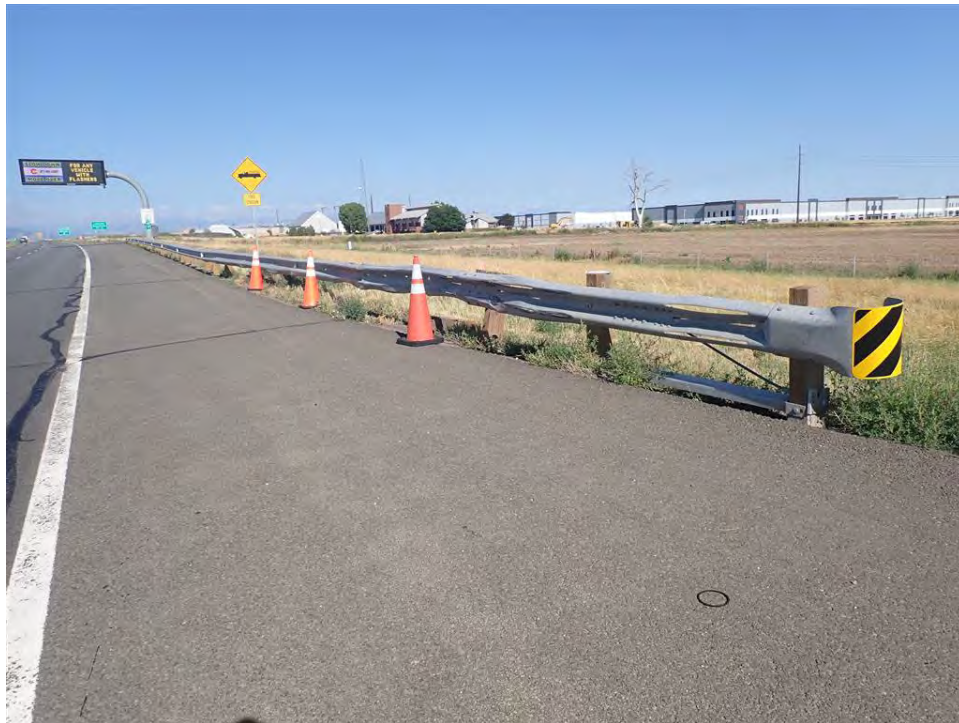
Photo 47: Missing and Damaged Guardrail Posts, Westbound at Milepost 47.35

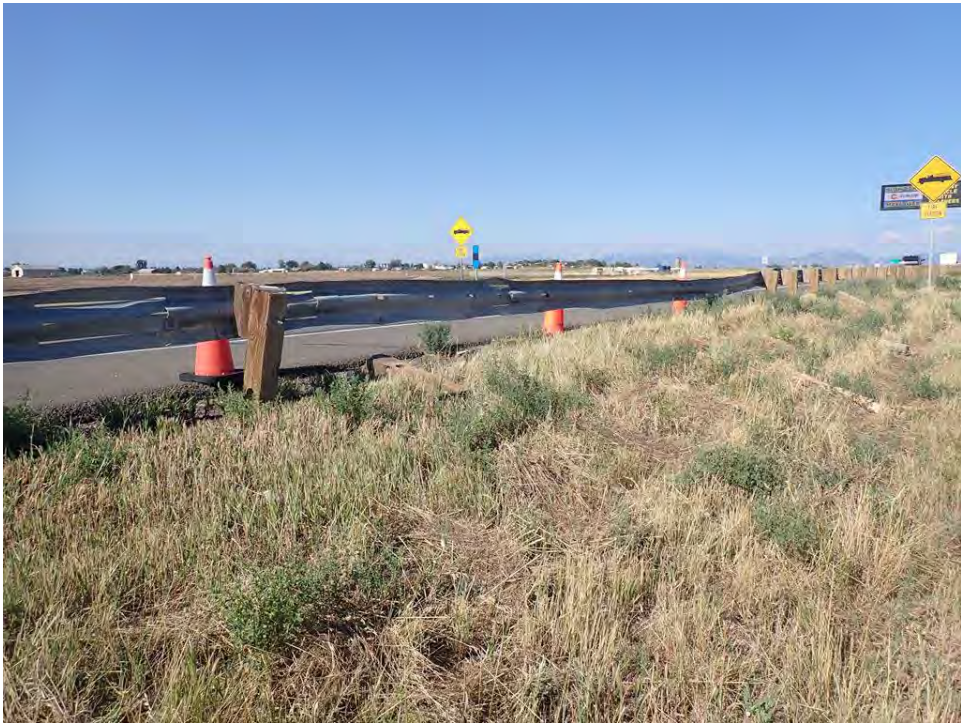
Photo 48: Damaged Guardrail Post, Westbound at Milepost 48.75

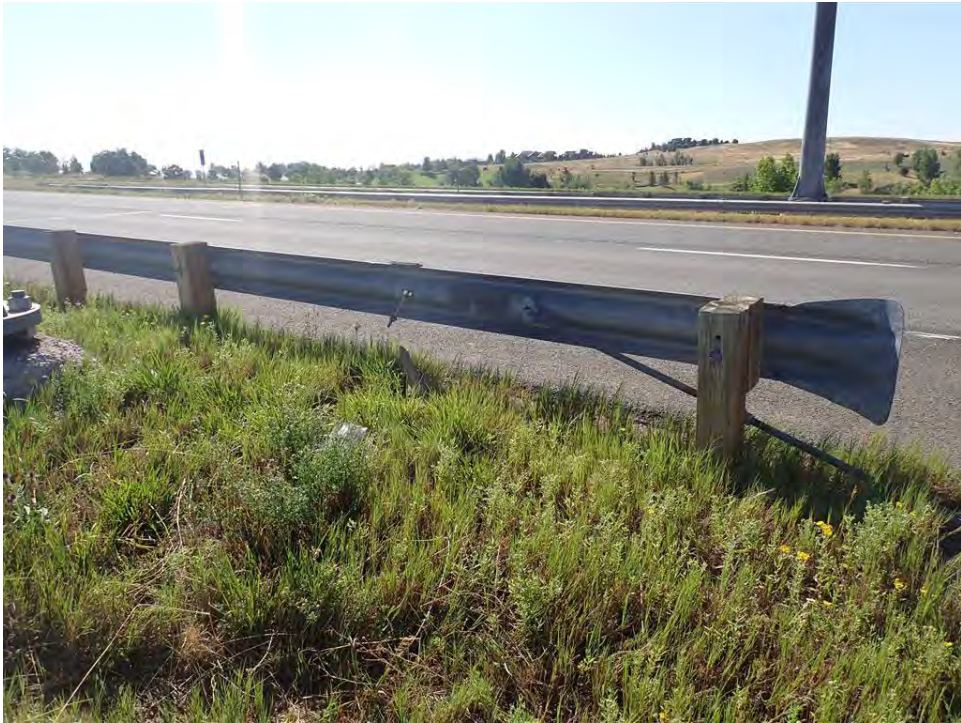
Photo 49: Damaged Guardrail Posts, Eastbound at Milepost 49.4

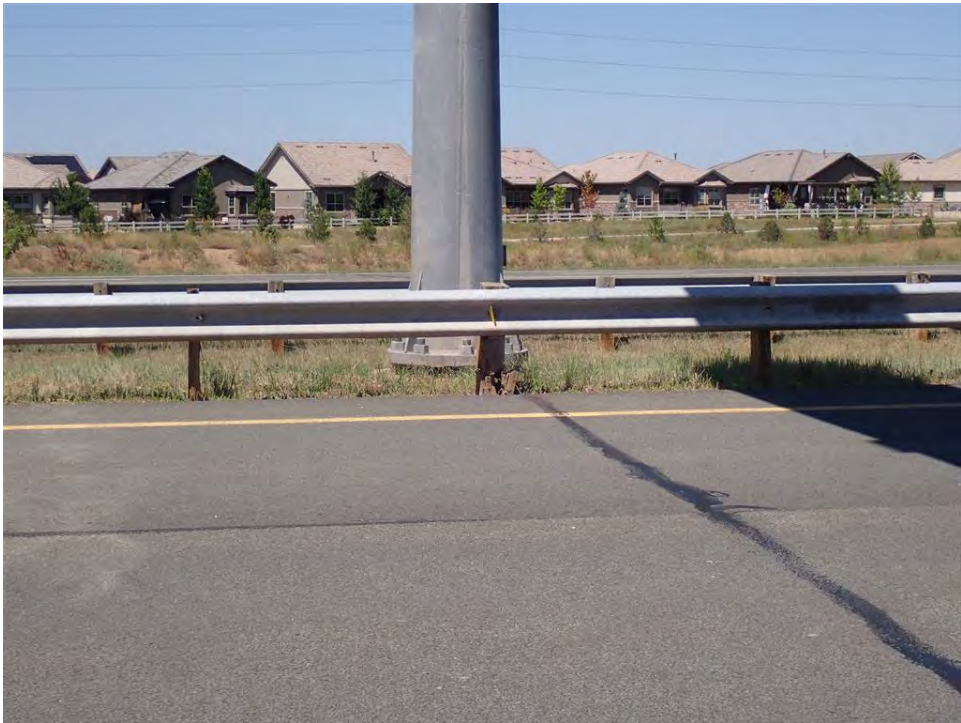
Photo 50: Typical Missing Timber Blockings in Median Guardrail (Milepost 51.05 Pictured)

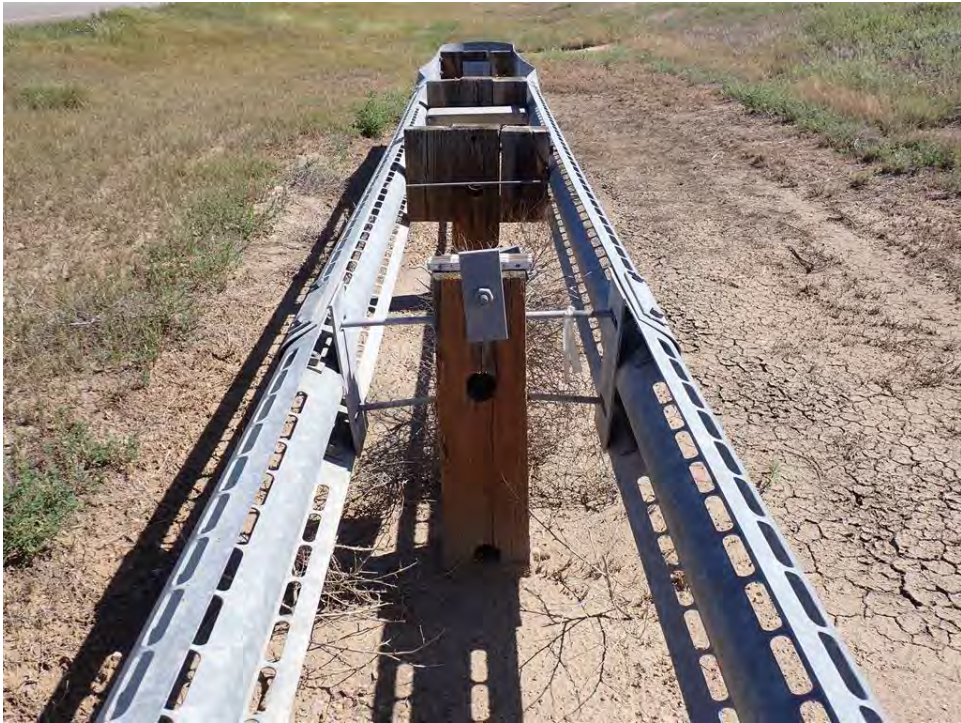
Photo 51: Typical Impact Damage to Steel Guardrail (Eastbound at Milepost 52.95 Pictured)

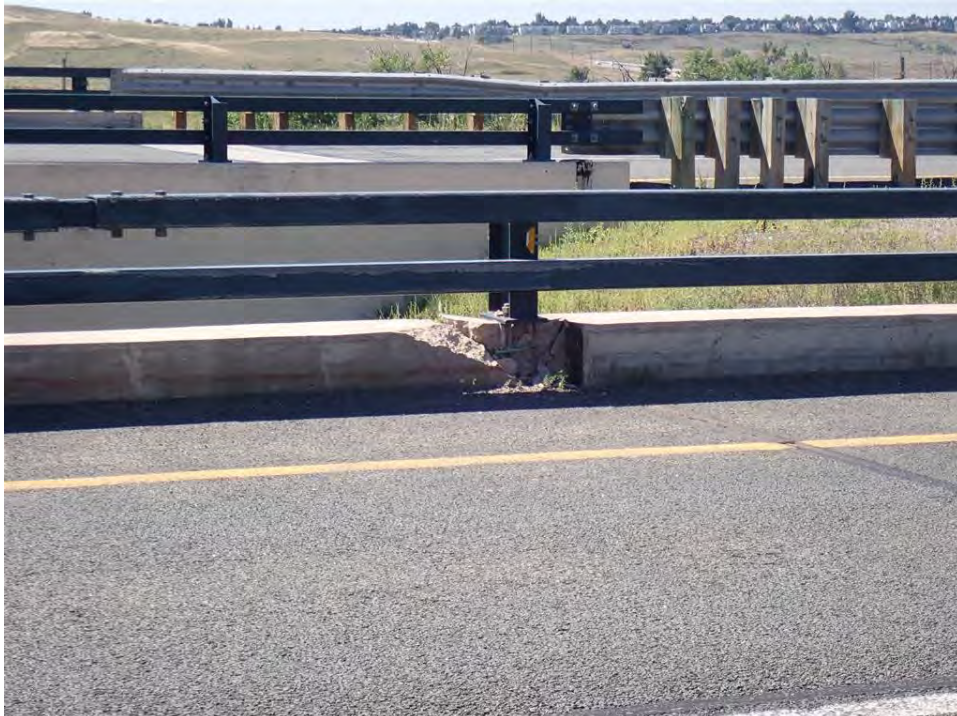
Photo 53: Impact Damage to Left Curb, Eastbound On-Ramp at Sheridan Parkway

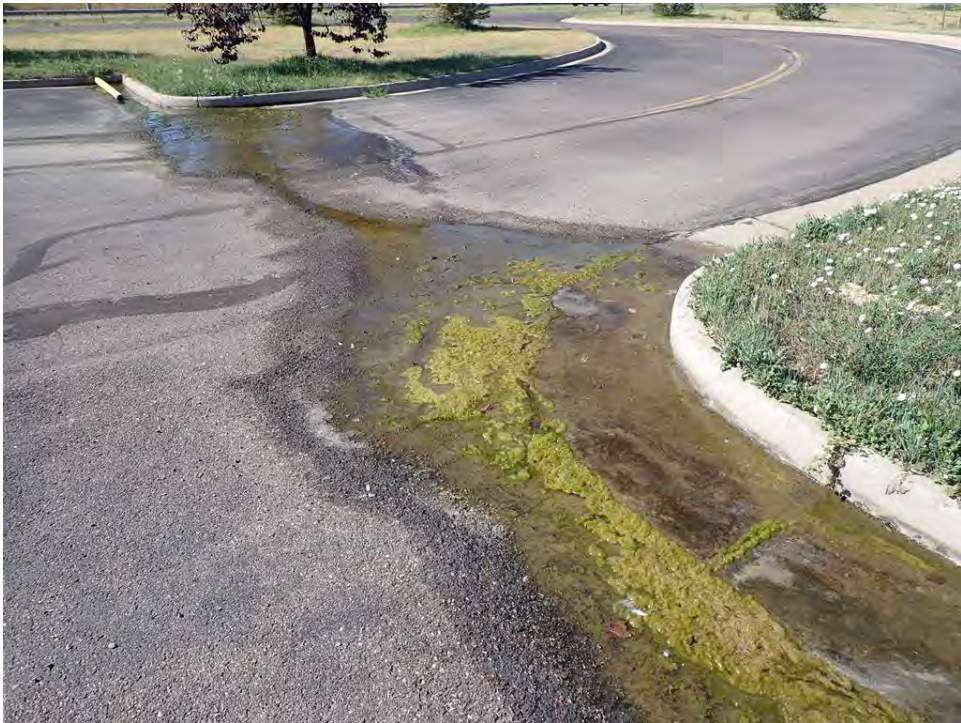
Photo 73: Drainage Across Parking Lot on West Side of Administration Building
