# 2023 Annual Inspection of the Northwest Parkway

October 6, 2023

Northwest Parkway, LLC  
3701 Northwest Parkway  
Broomfield, CO 80023  
Contact: Mr. Pedro Costa

Stantec Consulting Services Inc.  
410 17th Street  
Suite 1400  
Denver, Colorado 80202  
Contact: Ryan Nataluk, PE

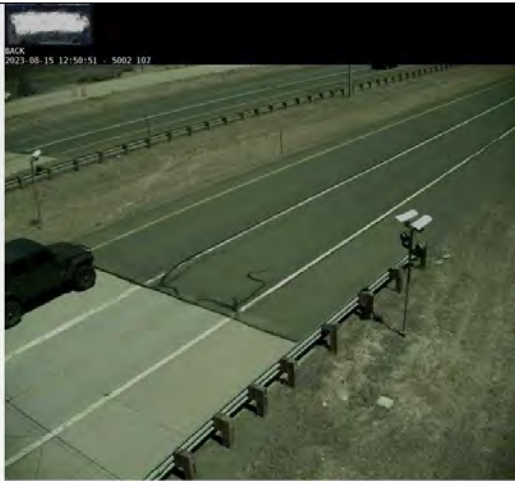
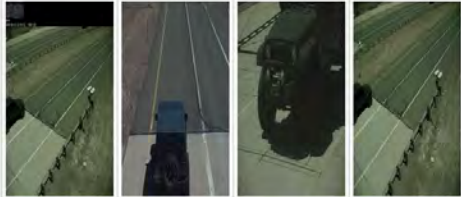
Figure 1: Example Toll Transaction Resulting in Vtoll

- **The User Classification System (UCS) shall accurately classify vehicles passing through the Toll Plaza:** Several hundred different vehicles were witnessed passing through the two lanes both directions at the toll plaza on August 15 and 16, 2023. The direction, lane, time, and number of axles of 91 of these vehicles were recorded. The time, lane, and direction of 42 vehicles were provided to the NWPLLC. The NWPLLC was able to provide the toll transaction for each of these vehicles, including a picture of the license plate and a vehicle classification (number of axles) on August 24, 2023. One four-axle vehicle was misclassified as a five-axle vehicle in the right lane of westbound at the toll plaza. Examples of toll transactions are shown below in Figure 1 and Figure 2. The axle misclassification transaction is shown below in Figure 3. **Score: 4.95**

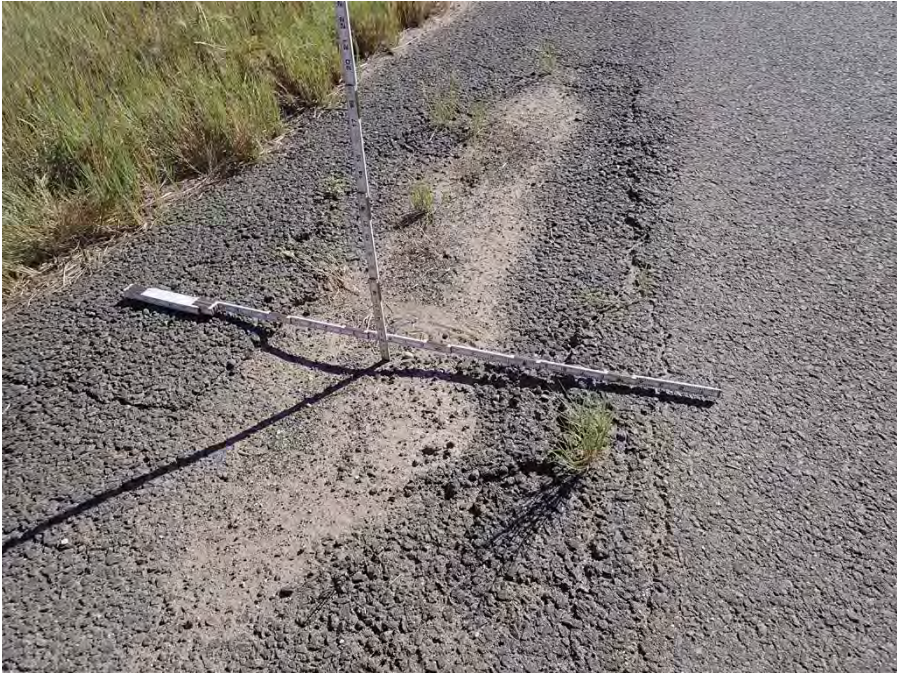
Photo 1: Rutting in North Shoulder, Westbound at Milepost 49.1

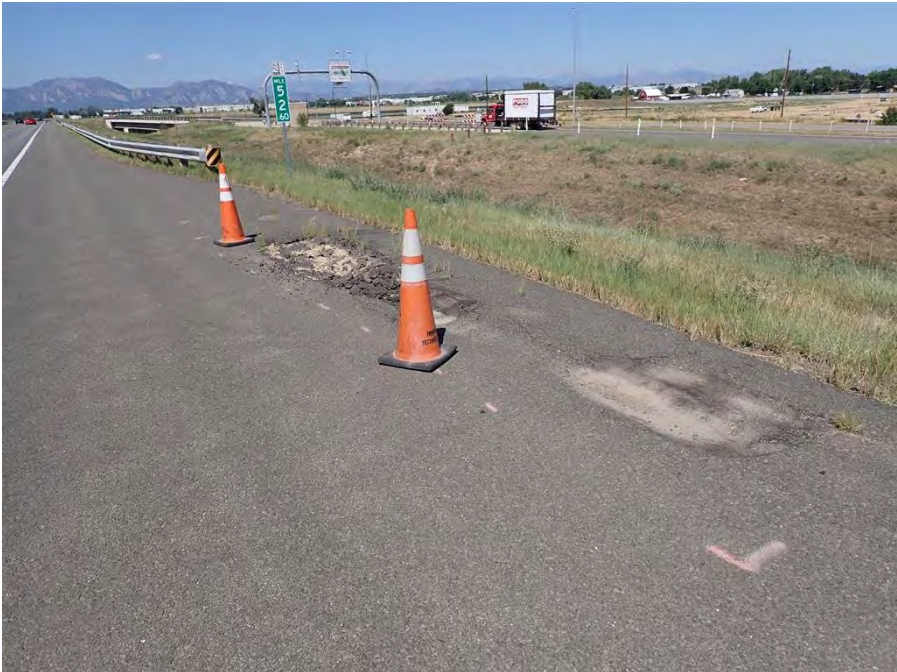
Photo 2: Overall of Rutting in North Shoulder, Westbound at Milepost 52.6

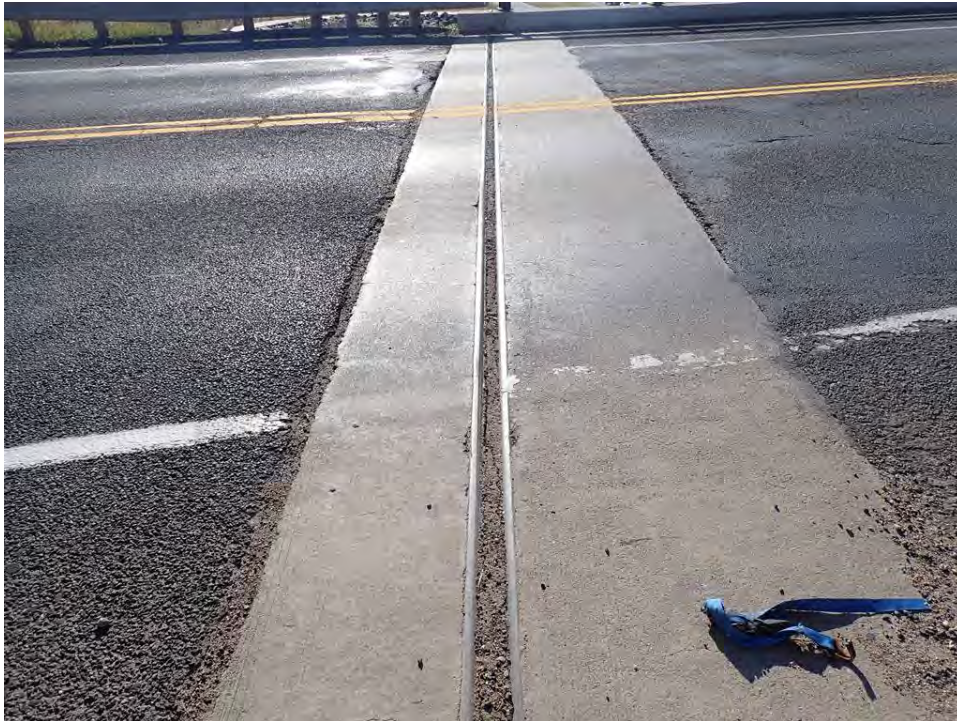
Photo 18: Dirt in Expansion Joint at Huron Overpass

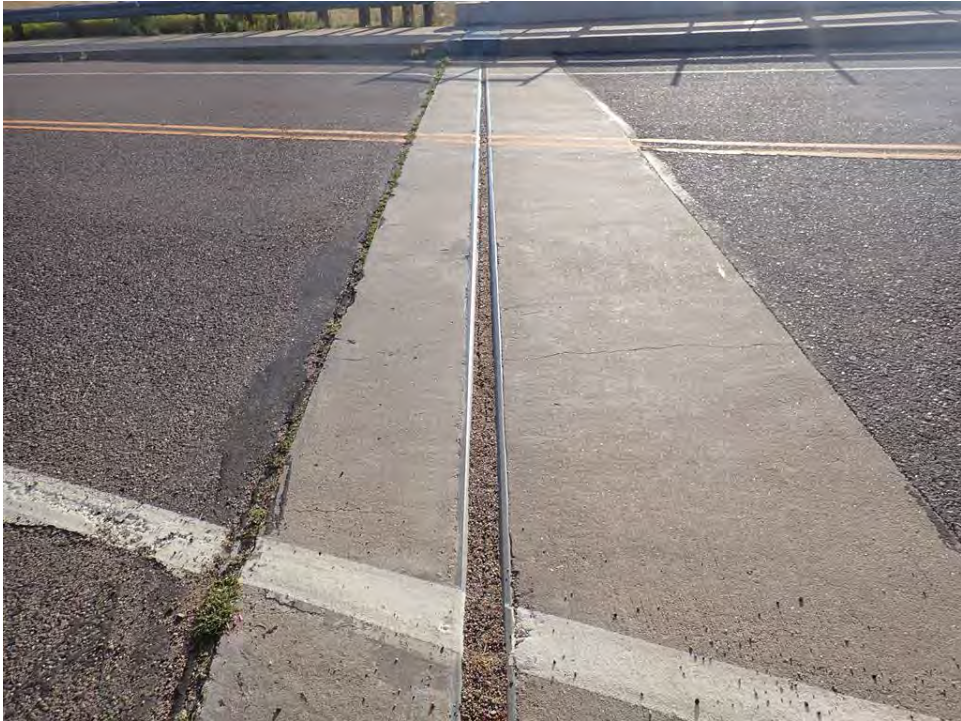
Photo 21: Dirt in Expansion Joint at 104<sup>th</sup> Overpass

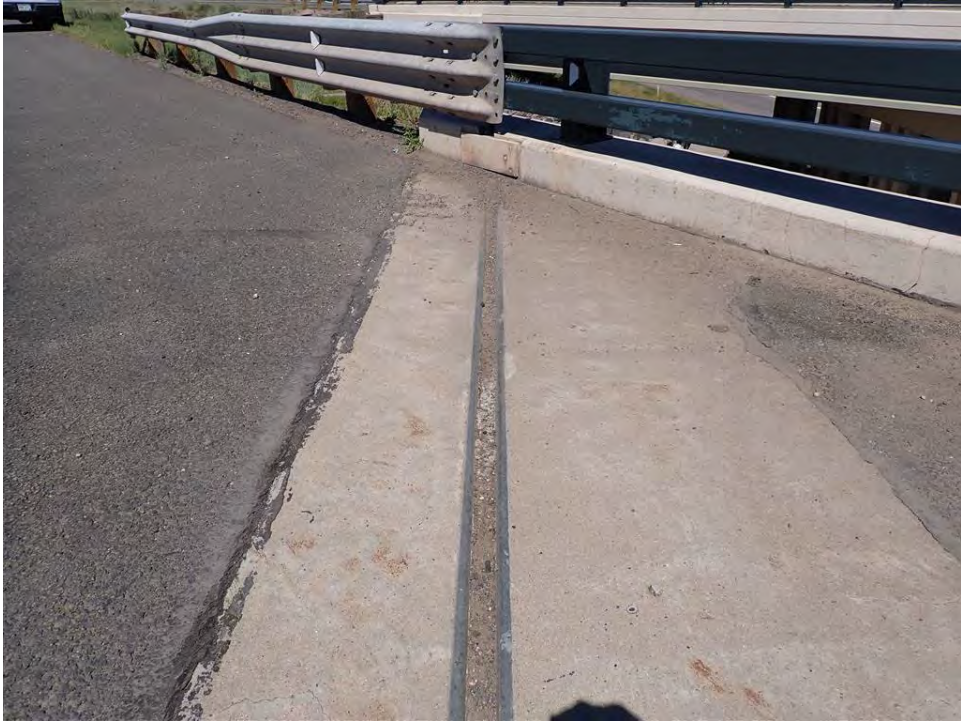
Photo 22: Dirt in Shoulder of Expansion Joint at Bridge over Eastbound Dillon Road, Westbound

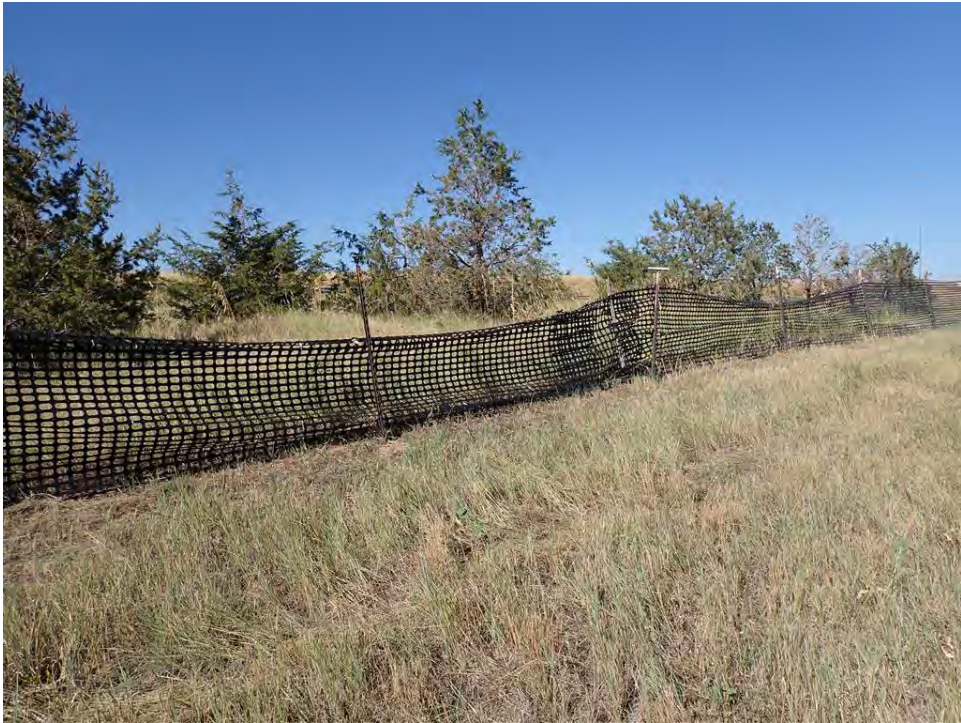
- North slope along westbound at milepost 50.25
    - North slope along westbound at milepost 51.05
  - Loose and sagging snow fence eastbound at milepost 46.7

Photo 36: Loose and Sagging Snow Fence, Eastbound at Milepost 46.7

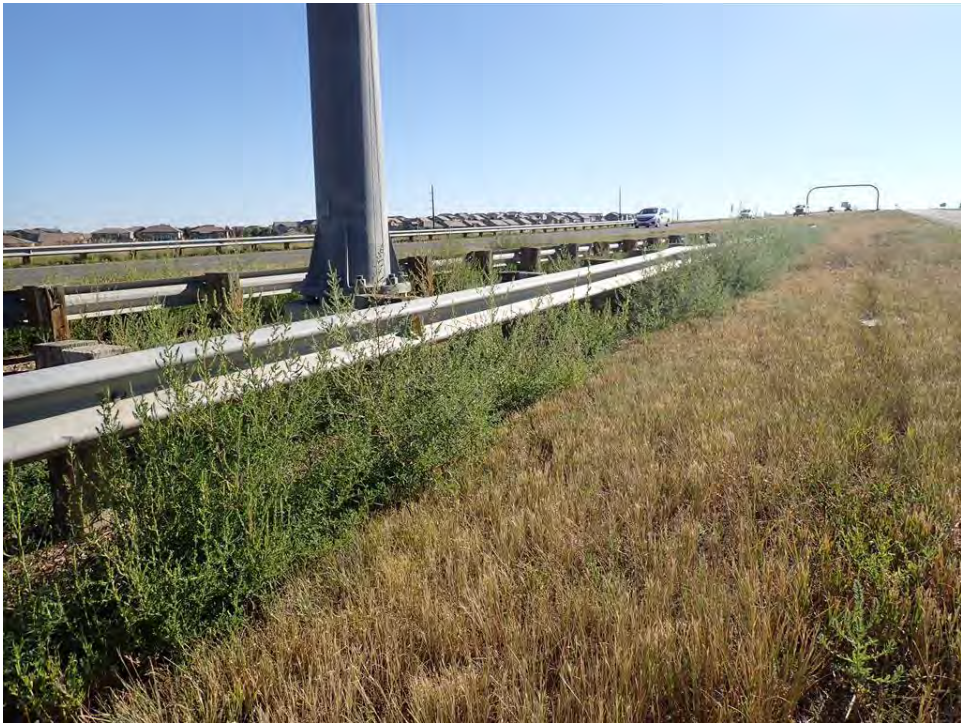
- **Appearance of landscaping:** The landscaping around the Toll Plaza and Maintenance facility was neat in appearance at the time of the inspection. The grass was mowed and trimmed. Bushes and shrubs were trimmed to provide a neat appearance. **Score: 5.0**
- **Noxious weeds:** Several areas of noxious weeds were observed throughout the parkway during the inspection, primarily around the guardrails in the median. The NWPLLC keeps a list of areas where noxious weeds are located within the right-of-way. These areas of infestations should be monitored and addressed through a spray program or by mechanical mowing. See Photo 39. Weeds had been trimmed and sprayed prior to the reinspection, as shown in Photo 40. **Score: 4.75**

Photo 39: Weeds Growing Around Median Guardrail, Milepost 48.85

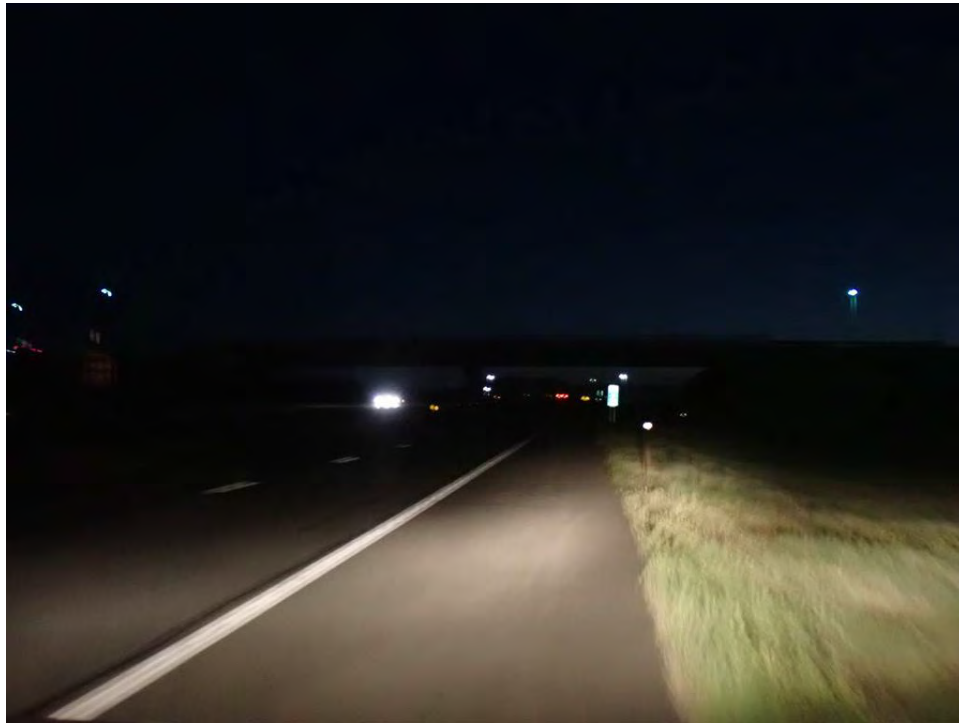
See Photo 57. **Score: 4.50**

Photo 57: Lights Out Under Sheridan Parkway Bridge and at Wingwalls

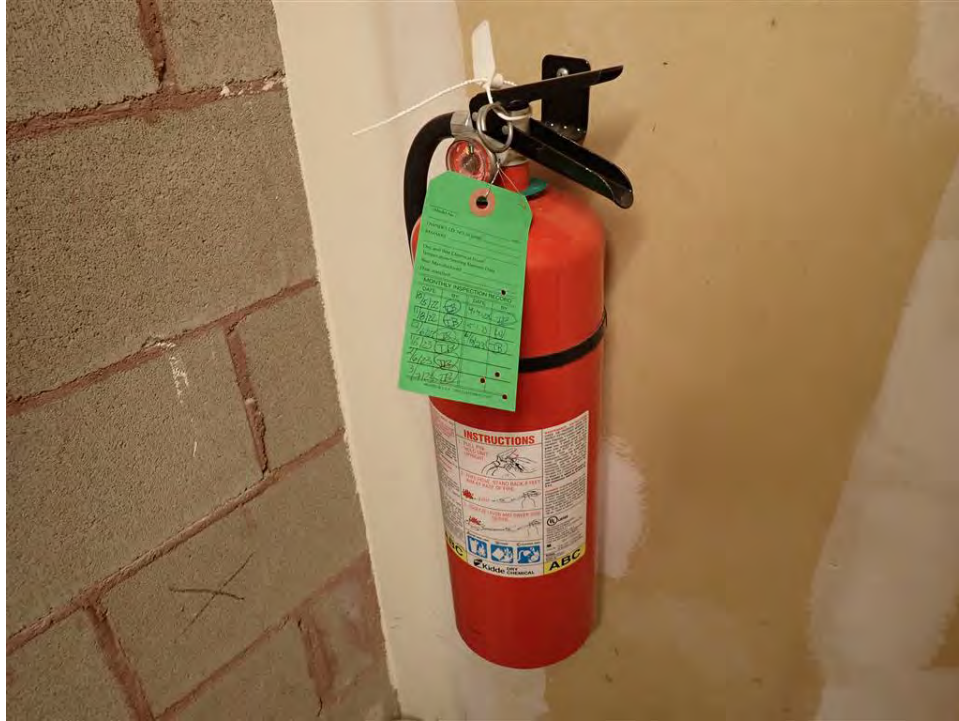
- **Elevator in the Admin Building:** The elevator was clean and operational. The last compliance test was on May 24, 2023. A file is kept at the NWPLLC facility for compliance inspection. Hydraulic Elevator Safety Test Reports are posted in the Elevator Room, and a copy is included in Appendix B. The fire extinguisher in the Elevator Room was fully charged, but the inspection tag was not signed off by maintenance staff in July or August 2023. See Photo 59. **Score: 4.95**

Photo 59: Fire Extinguisher Inspection Tag Not Signed Off in July or August in Elevator Room

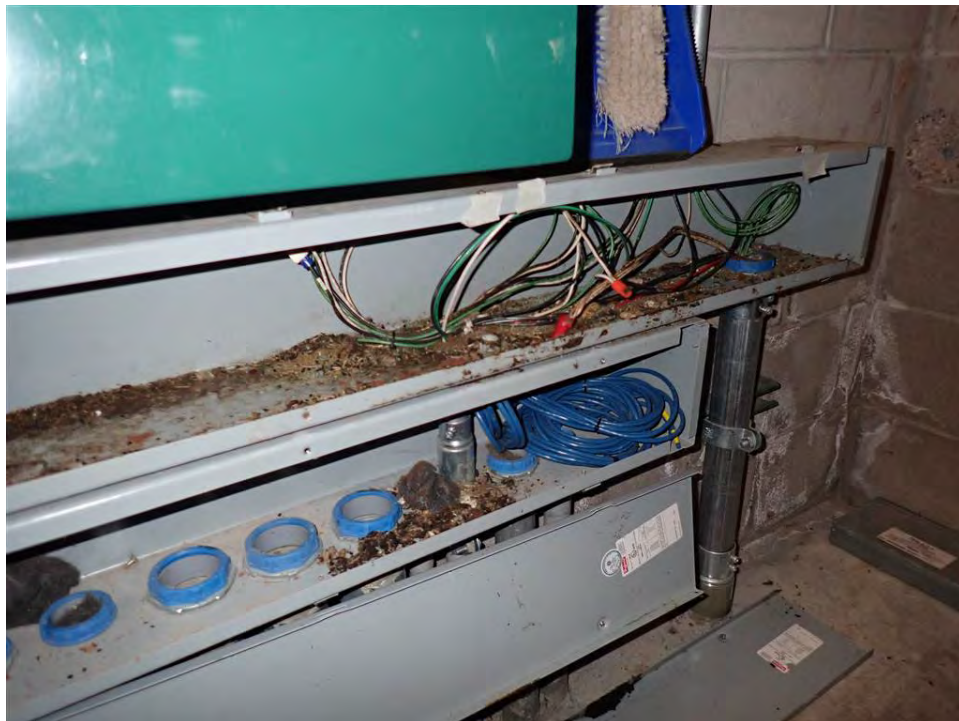
Photo 62: Evidence of Mice in Electrical Cabinet in Toll Booth Building, Westbound On-Ramp at US 287

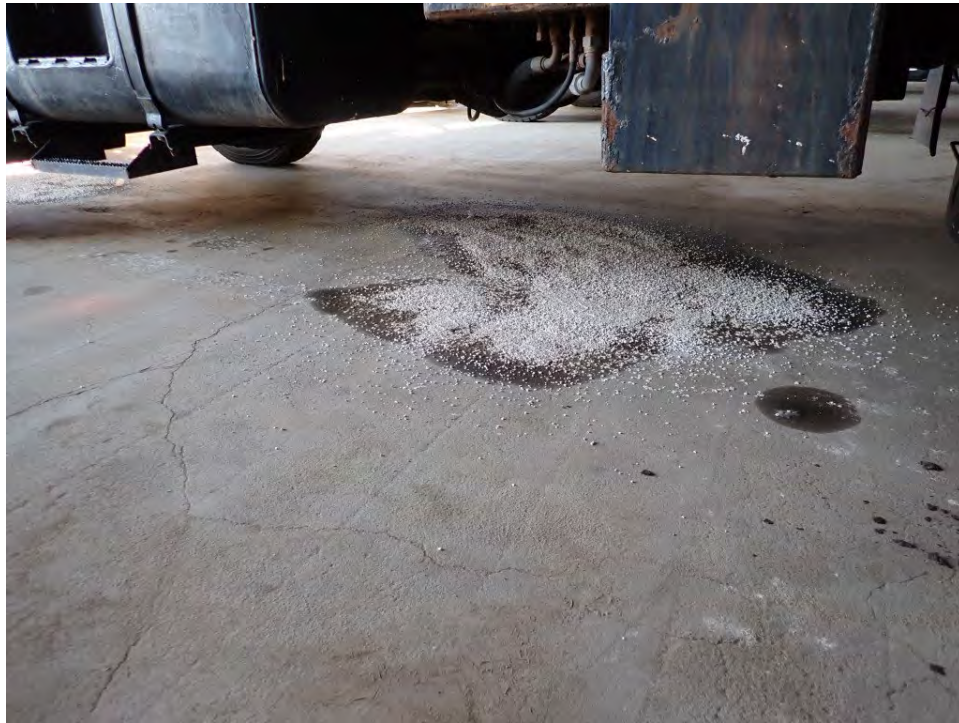
- **Equipment Shed:** This is an open-air steel building used to store equipment. It has a concrete floor and storage for up to six tandem trucks equipped with snowplows and sanders. The northwest corner was being utilized for storage. Dirt, debris, and bird droppings and feathers were observed on the floor in the equipment shed. Oil and/or hydraulic fluid was built up on the floor under and around some of the trucks; see Photo 63. It is recommended to clean the floors once maintenance is completed on the trucks and all leaks have been addressed. At the time of reinspection, the floor of the equipment shed had been cleaned and oil absorbent was placed on the floor under the truck leaks, as shown in Photo 64 and Photo 65. **Score: 4.75**

Photo 65: Oil Absorbent Placed on Floor of Equipment Shed Under Leaks

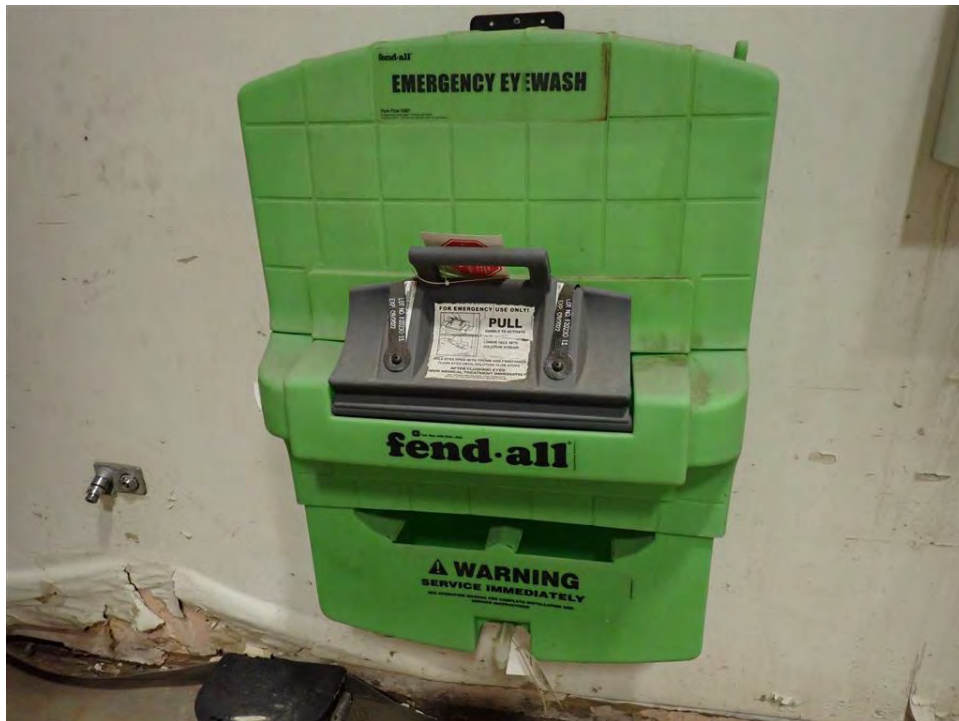
- **Equipment Maintenance and Cleaning Building:** Vehicle maintenance and service is completed in this building. The building has an area to clean/inspect equipment and has a work area. The fire extinguisher at the door was fully charged and signed off by maintenance staff. This building contains an eye wash station and first aid kit. No inspection tag was present on the eye wash station and the lot expiration tag is valid through 09/2022; see Photo 66. There are various oil barrels with different types of fluids that are needed for the equipment that is used in maintaining the NWP. This building also has a used oil storage container. The fluid storage containers were observed to be well labeled and easily read at the time of the inspection; see Photo 67. Pesticides were stored in a triple-walled storage container. A MSDS label was observed on the wall next to the eye wash station, however no SDS sheets were observed for any of the fluids stored in the building; see Photo 68. If SDSs are required for the materials in the building it is recommended to post them at this location; otherwise, the MSDS label on the wall should be removed. Flammable materials were observed to be stored in approved cabinets. **Score: 4.85**

Photo 66: Eye Wash Station in Equipment Maintenance and Cleaning Building, Expired Lot Tag

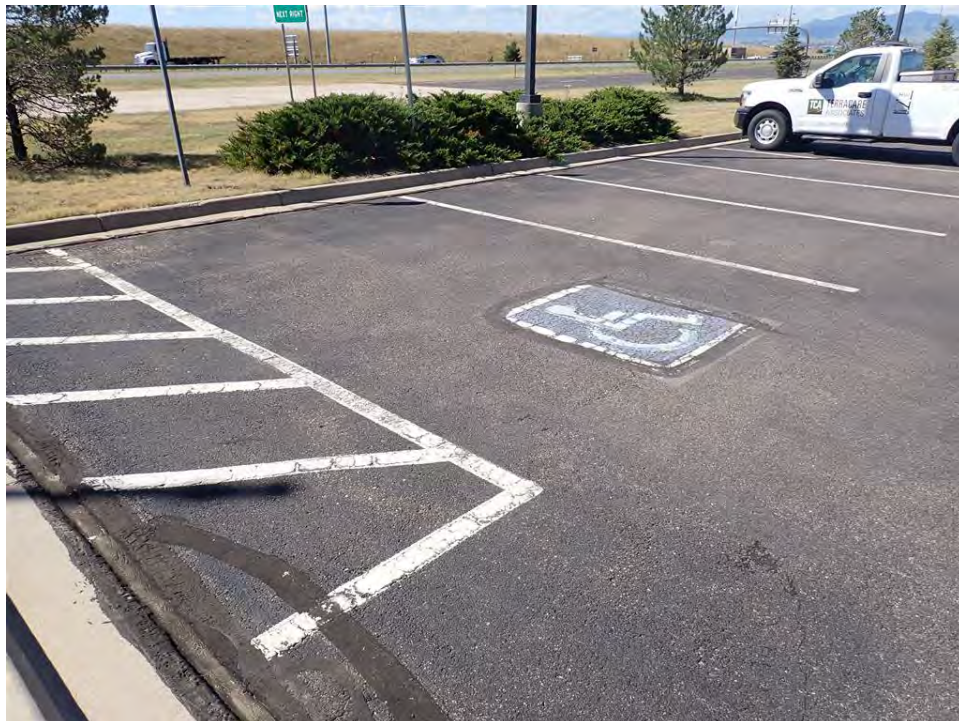
Photo 72: Faded Paint on Asphalt in Parking Lot on West Side of Administration Building
